INDOOR AIR QUALITY ASSESSMENT

**Sullivan Middle School
150 Draper Street
Lowell, Massachusetts**

Prepared by:
Massachusetts Department of Public Health
Bureau of Environmental Health Assessment
February, 2001

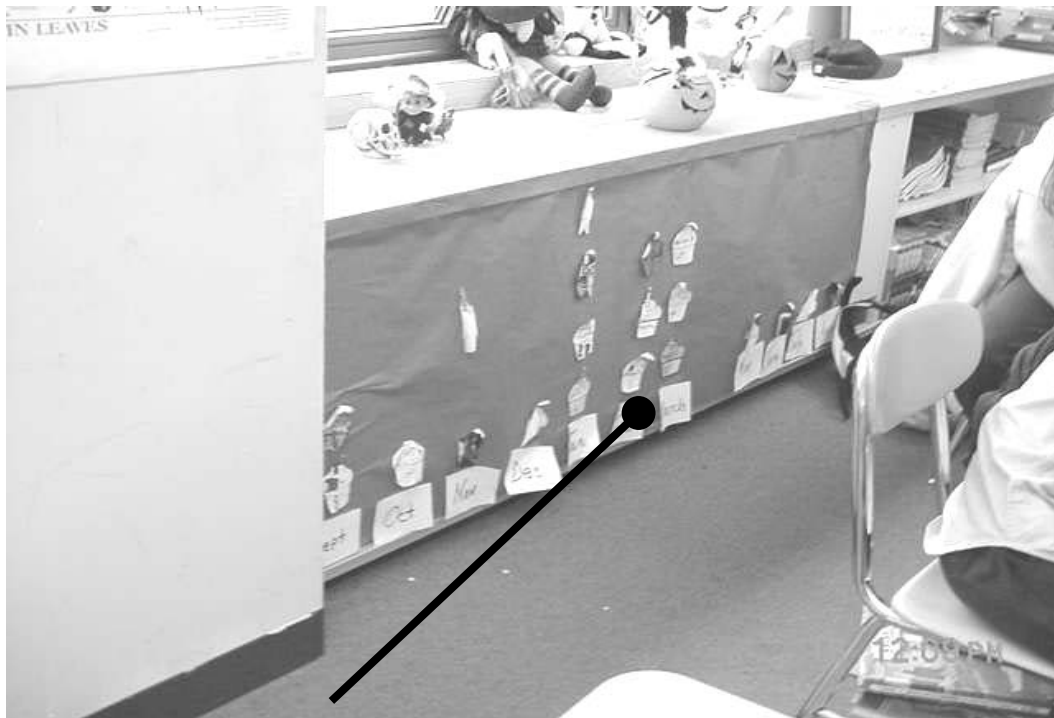
Picture 1

Fresh air in most classrooms is supplied by a unit ventilator (univent) system (see [Picture 1](#)) controlled by a computer-pneumatic interface system. This system is controlled electronically from an off-site location. Univents draw air from outdoors through a fresh air intake located on the exterior walls of the building (see Picture 2) and return air through an air intake located at the base of each unit. The mixture of fresh and return air is drawn through a filter and a heating/cooling coil, and is then provided to classrooms from the univent by motorized fans through fresh air diffusers located at the top of the unit (see Figure 1).

papers and posters on top of univents, and bookcases, tables and desks in front of univent returns were also seen in a number of classrooms (see Pictures 1 & 3). To function as designed, univent fresh air diffusers and return vents must remain free of obstructions. It is important that these units be activated and allowed to operate during school hours.

univent return vent

Classroom Univent - Note Return Vent on front of Unit Blocked by Sheet

6. Remove all blockages from univents to ensure adequate airflow. Clean out interiors of univents regularly.
7. Once both the fresh air supply and the exhaust ventilation are functioning properly, the system should be balanced by an HVAC engineer.

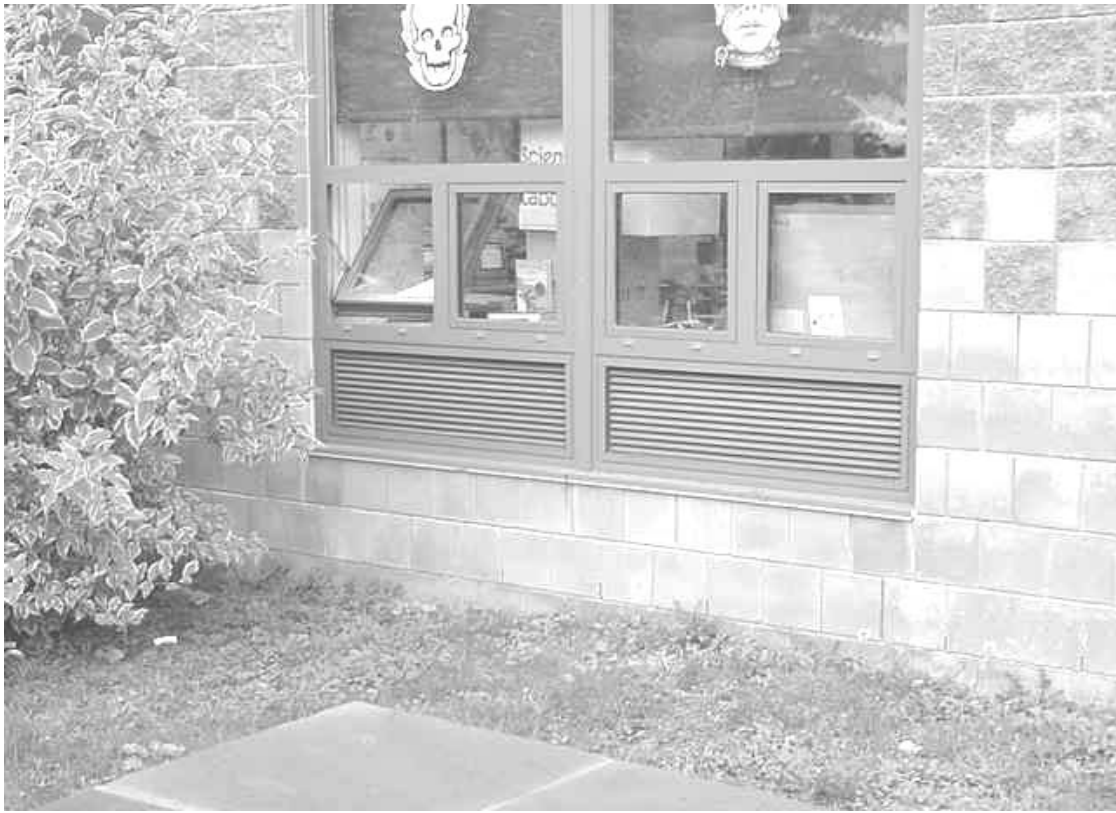
Picture 2

Univent Fresh Air Intakes on Exterior of School

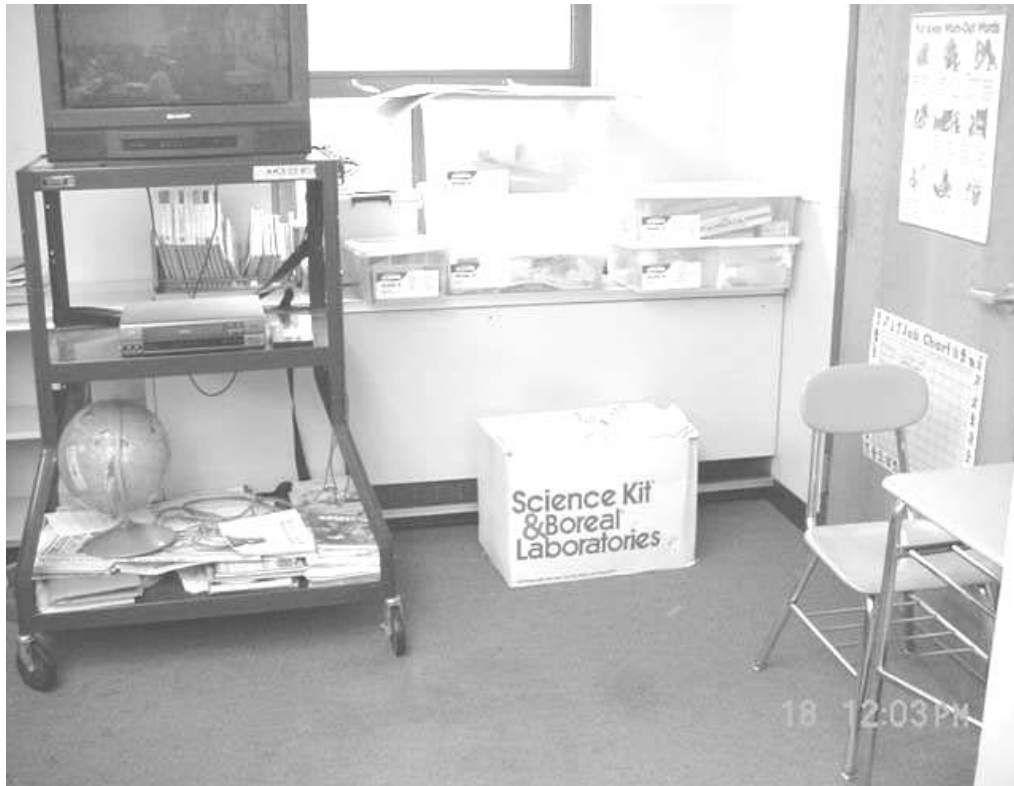
Picture 3

Univent Air Diffuser Obstructed by Storage Boxes

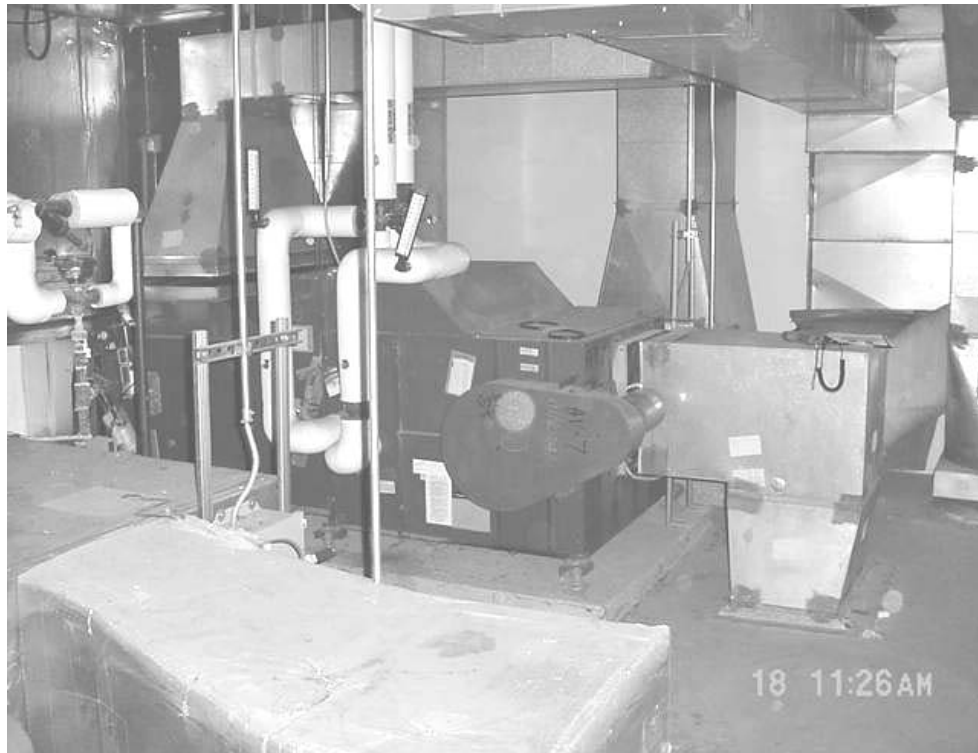
Picture 6

Ventilation for modular classrooms, core rooms and common areas is provided by ducted air handling units (AHUs) located on the roof or in mechanical rooms (see Pictures 6 & 7). Each modular classroom has its own AHU. Fresh air is distributed via ductwork connected to ceiling-mounted air diffusers. The amount of fresh air drawn into the units is controlled by moveable louvers connected to an activator motor that adjusts to alter fresh air intake. Return vents draw air back to the units through wall or ceiling-mounted grilles. Thermostats control each heating, ventilating and air conditioning (HVAC) system (see Picture 8). In modular classrooms, thermostats have settings of “on” and “automatic”. Thermostats were set to the “automatic” setting in all of the modular rooms surveyed during the assessment. The automatic setting on the thermostat

Air Handling Unit Located in Second Floor Mechanical Room

3. Examine each AHU and univent and for proper function. Survey equipment to ascertain if an adequate air supply exists for each area serviced. Consider consulting a heating, ventilation and air conditioning (HVAC) engineer concerning the maintenance and calibration of HVAC equipment and univent fresh air control dampers school-wide.

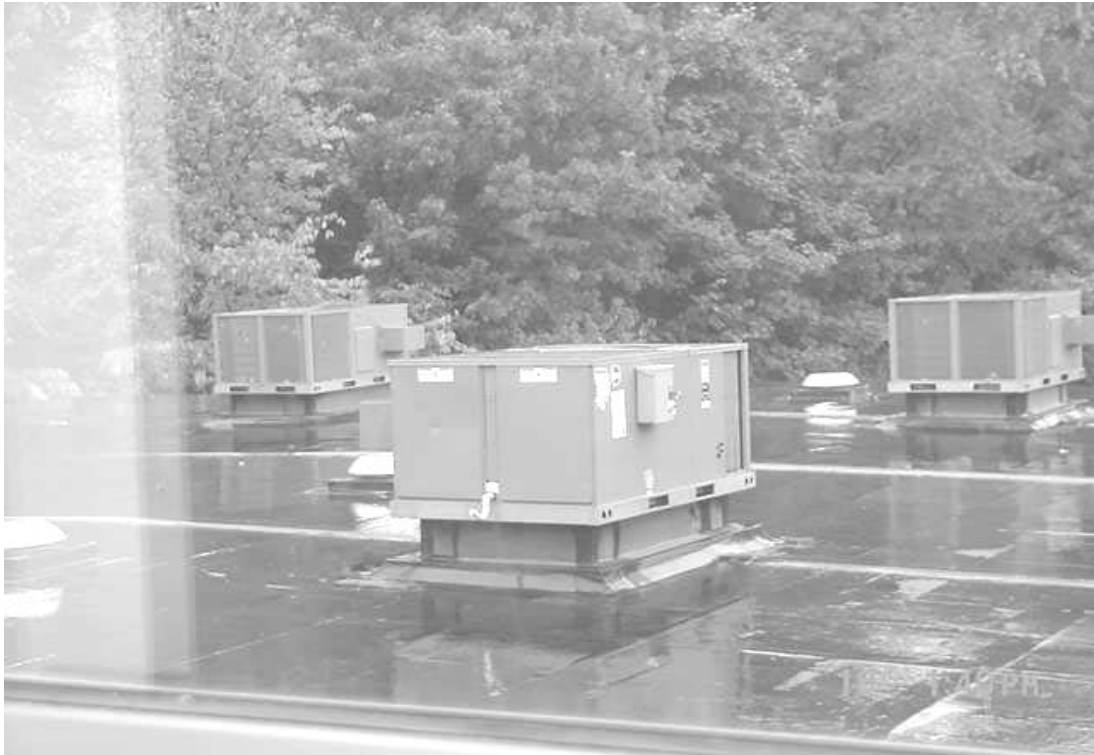
Picture 7

Rooftop Air Handling Units for Modular Classrooms

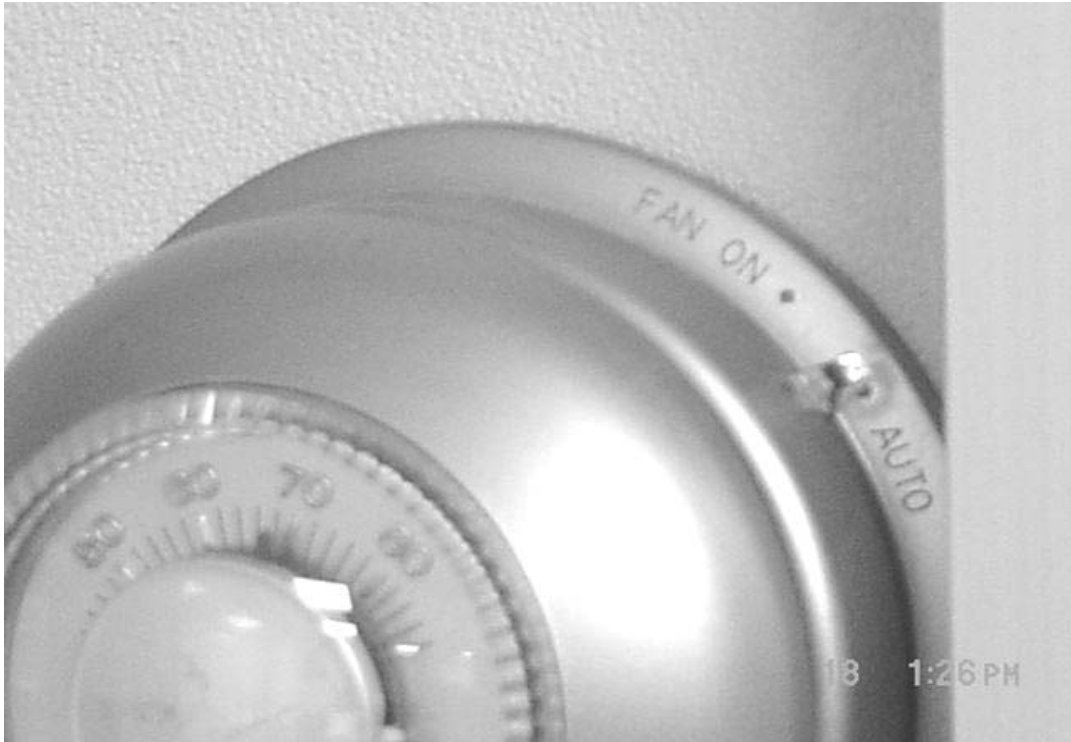
Picture 8

activates the HVAC system at a pre-set temperature. Once a pre-set temperature is measured by the thermostat, the HVAC system is deactivated. Therefore no mechanical ventilation is provided until the thermostat re-activates the system.

Close-up of Modular Classroom Thermostat - Note Thermostat Set to “Auto” Position

2. To maximize air exchange, the BEHA recommends that both supply and exhaust ventilation operate continuously during periods of school occupancy independent of classroom thermostat control.

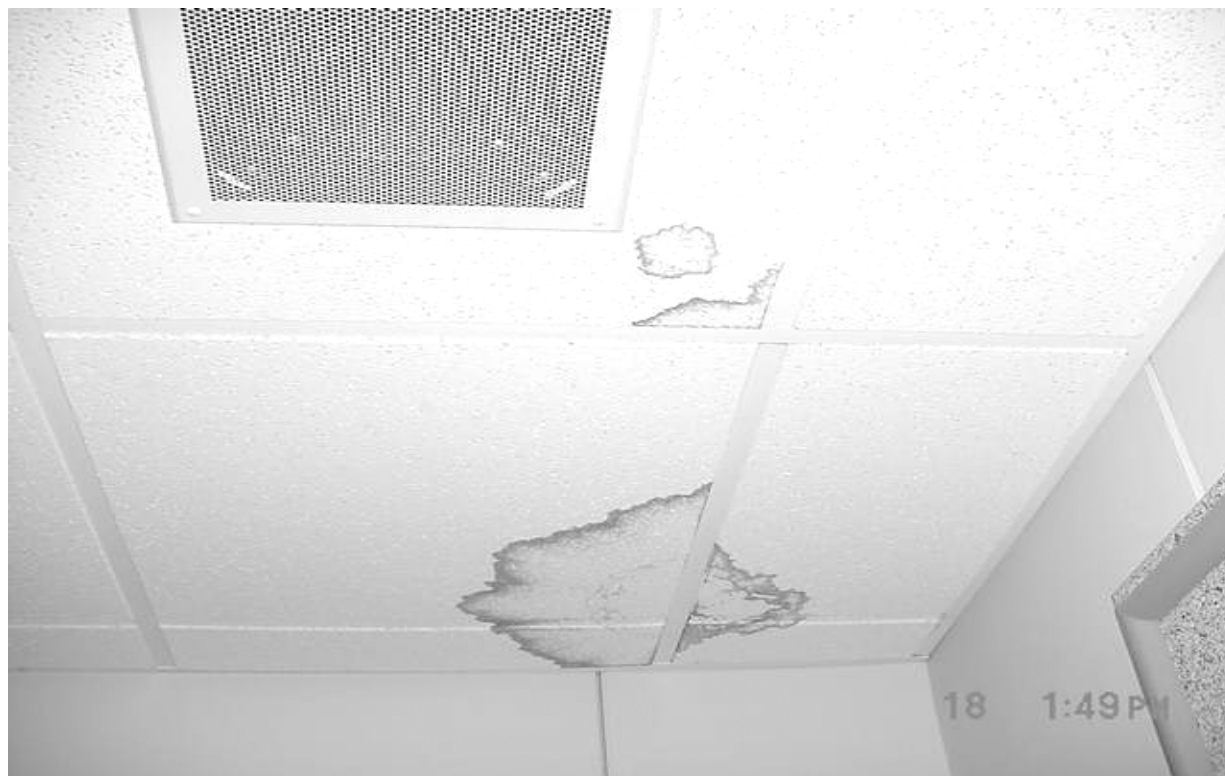
Picture 9

Stained ceiling tiles were observed in some areas (see Picture 9). Water-damaged ceiling tiles can provide a source of mold and mildew and should be replaced after a water leak is discovered. A few areas had plants (see Tables). Plant soil and drip pans can serve as source of mold growth. A number of plants did not have drip pans. The library had plants on the carpet. Classroom 210 had a plant on the univent. The lack of drip pans and/or over-watering can lead to water pooling and mold growth on porous materials (e.g. carpeting). Plants should be properly maintained and be equipped with drip pans. Plants should also be located away from the air stream of mechanical ventilation to prevent aerosolization of dirt, pollen or mold.

Stained Ceiling Tiles in Modular Classroom

11. Replace any water-damaged ceiling tiles, insulation and building materials. Examine the areas above and around these areas for mold growth. Repair water leaks and disinfect areas of water leakage with an appropriate antimicrobial if necessary.

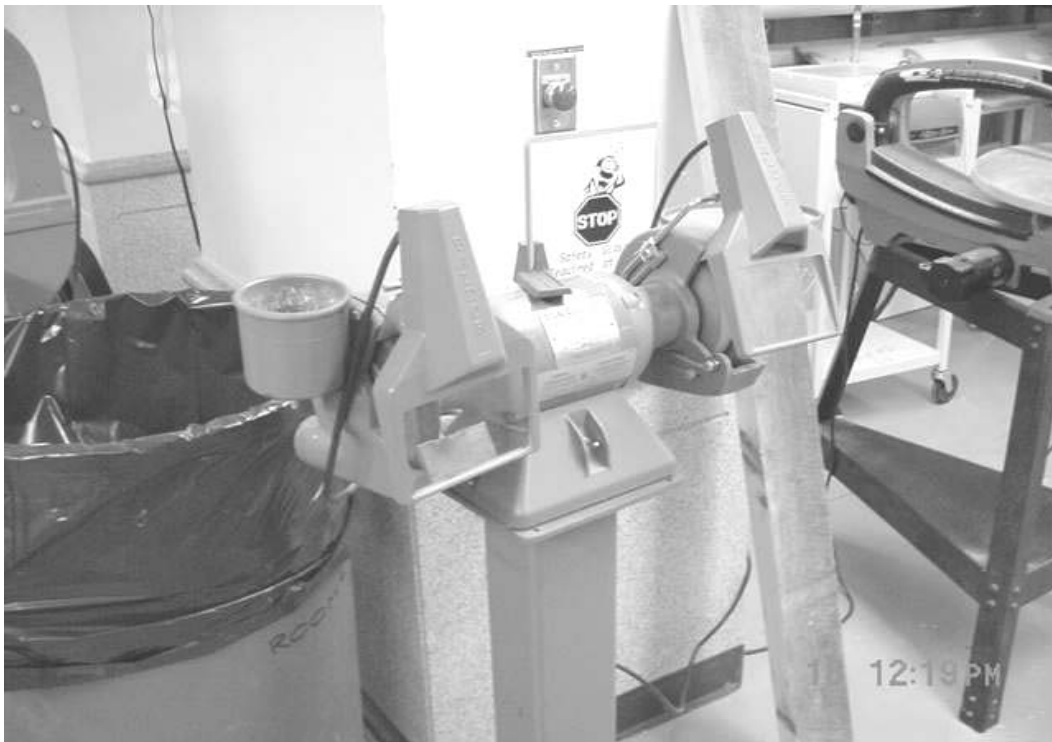
Picture 10

The wood-shop is not equipped with a wood dust collection system. There are wood cutting/sanding machines and a grinding machine in the shop (see Picture 10). As grinding machines grind or cut metal, heated metal particles (called fume) is produced and aerosolized. Wood dust and metal fumes are respiratory irritants. These machines should be equipped with local exhaust ventilation to prevent the aerosolization of wood dust and particulate matter.

Unvented Grinding Machine in Wood Shop

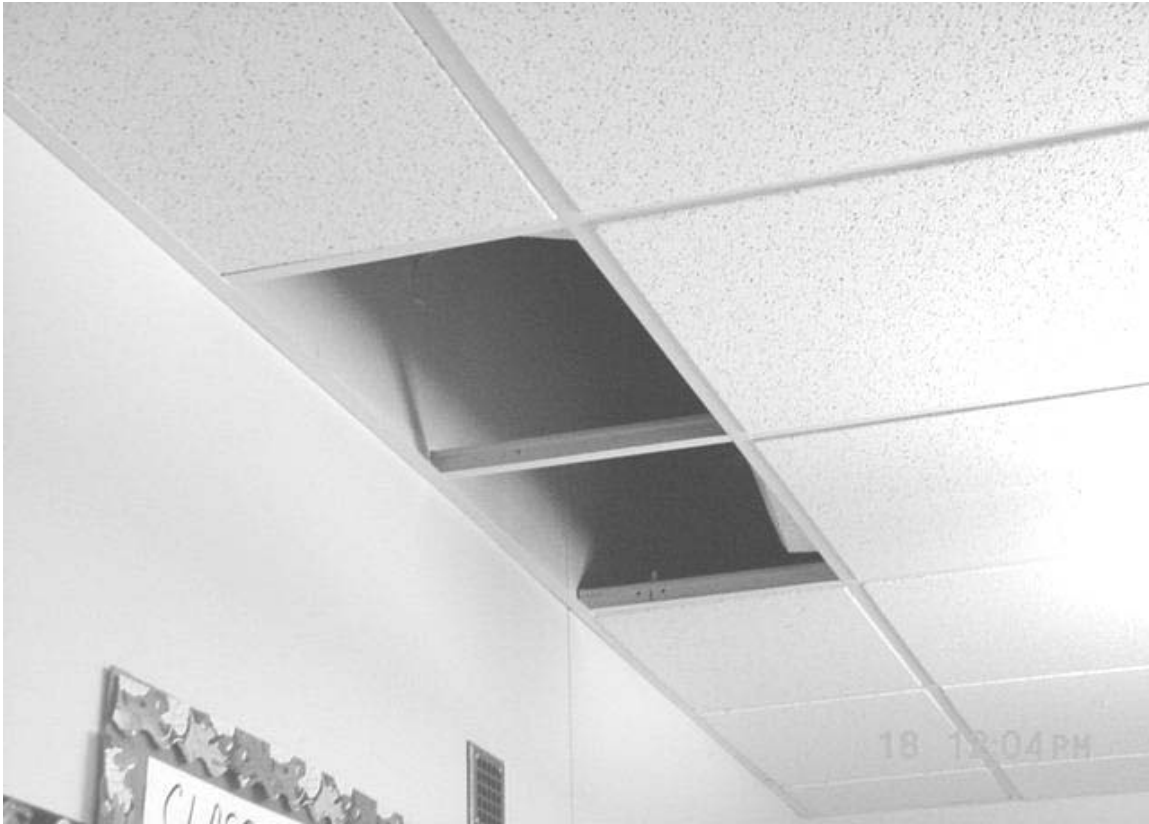
Picture 12

irritating to the eyes, nose and throat. Accumulated chalk dust was noted in several classrooms (see Picture 11). Chalk dust is a fine particulate, which can be easily aerosolized and is an eye and respiratory irritant. Several areas had missing ceiling tiles (see Picture 12). Missing ceiling tiles can provide an egress for dirt, dust and particulate matter into occupied areas. These materials can also be irritating for certain individuals.

Missing Ceiling Tiles

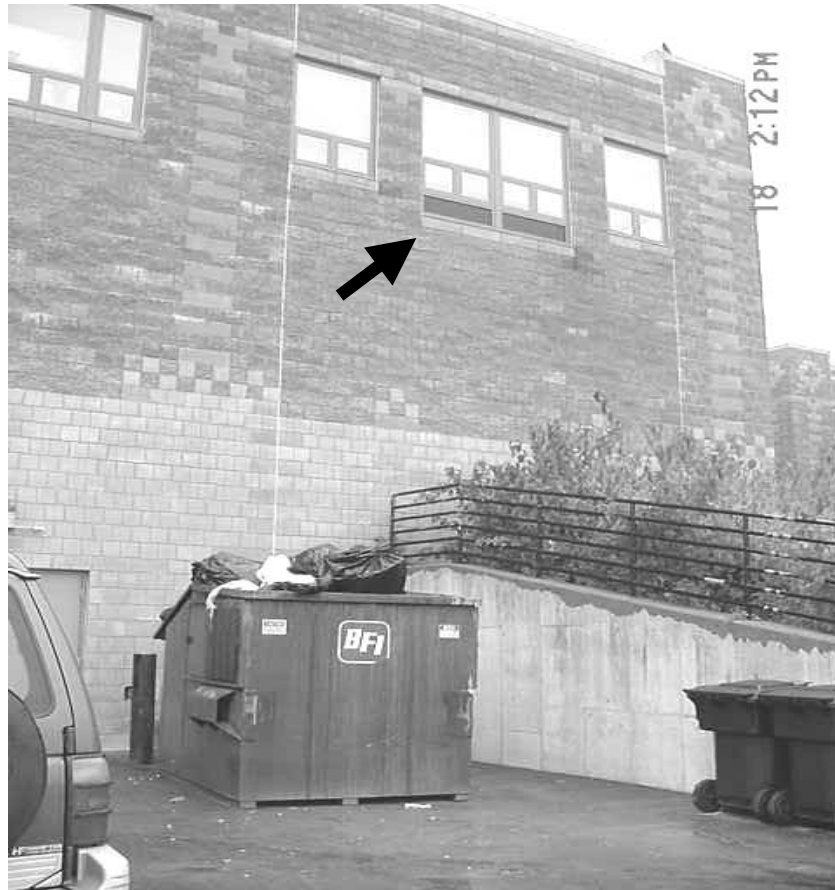
Picture 13

The school's dumpster is located behind the building. Although no reports of trash odors were reported, the close proximity of the dumpster to the building may provide for nuisance odors to enter classrooms through the univent fresh air intake (see Picture 13) or by open windows during the Spring and Summer months.

**Dumpster Located below Univent Fresh Air Intake
Note Trash Piled on Top of Dumpster**

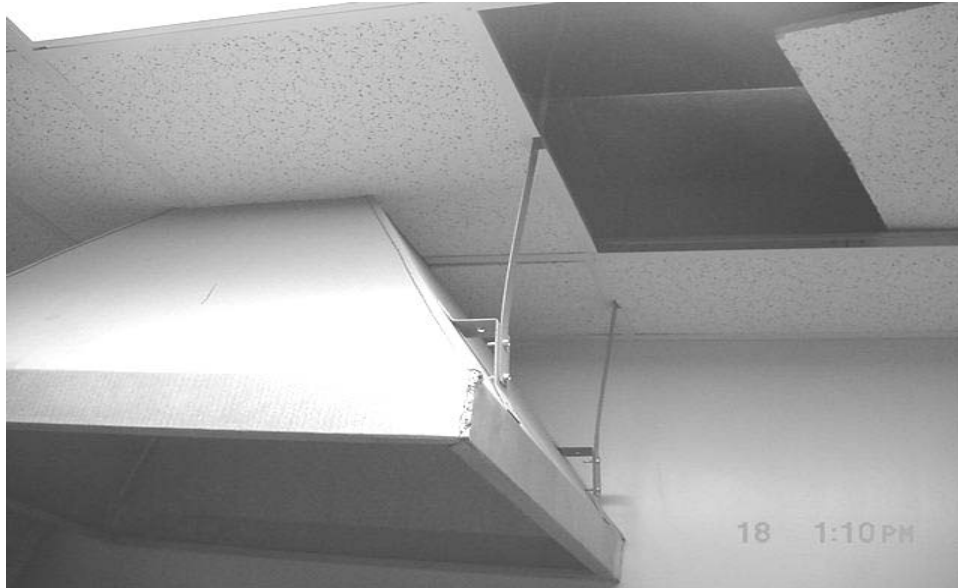
Picture 14

Pottery items were noted drying on top of the univent in art room 141. Accumulated dirt/dust/pottery debris was also noted within the interior of the univent. Clay dust is a fine particulate that can be easily aerosolized and distributed by the air stream of the univent diffuser. Accumulated dirt/dust/debris was also noted in several other classroom univents. Room 142 contained a kiln. The local exhaust hood over the kiln was examined and was not functional during the assessment (see Picture 14). Kiln exhaust may contain corrosive, hazardous and irritating materials including chlorine, sulfur dioxide and carbon monoxide, and should be provided with dedicated local exhaust ventilation (McCann, 1985). Without local exhaust ventilation, pollutants produced by the pottery kiln can penetrate into adjacent areas of the school.

**Local Exhaust Hood for Pottery Kiln
Note Vent Hood was Non-Functional During the Assessment**

- mold/mildew growth, repair/replace as necessary. Disinfect areas of microbial growth with an appropriate antimicrobial as needed.
13. Examine carpeting for water damage and remove/replace if moldy. Disinfect areas of floor underneath water-damaged carpeting with an appropriate antimicrobial.
 14. Store cleaning products and chemicals properly and keep out of reach of students.
 15. Ensure exhaust ventilation is functioning in areas that contain photocopiers.
 16. Refrain from using strong scented materials in classrooms and restrooms.
 17. Ensure aquariums are properly cleaned to prevent odors and/or algae growth.
 18. Replace missing ceiling tiles to prevent the egress of dirt, dust and particulate matter into occupied areas.
 19. Consider discontinuing the use of the kiln until local exhaust ventilation system is repaired/reactivated.
